# Service Bulletin

NO.1284

**Subject: Cover sub-assembly and Charge Pump (Pump Plate)  
Model 11 Transmissions, Model 11 Pumps, 1150 Transaxles, with  
external charge pump inlet.**

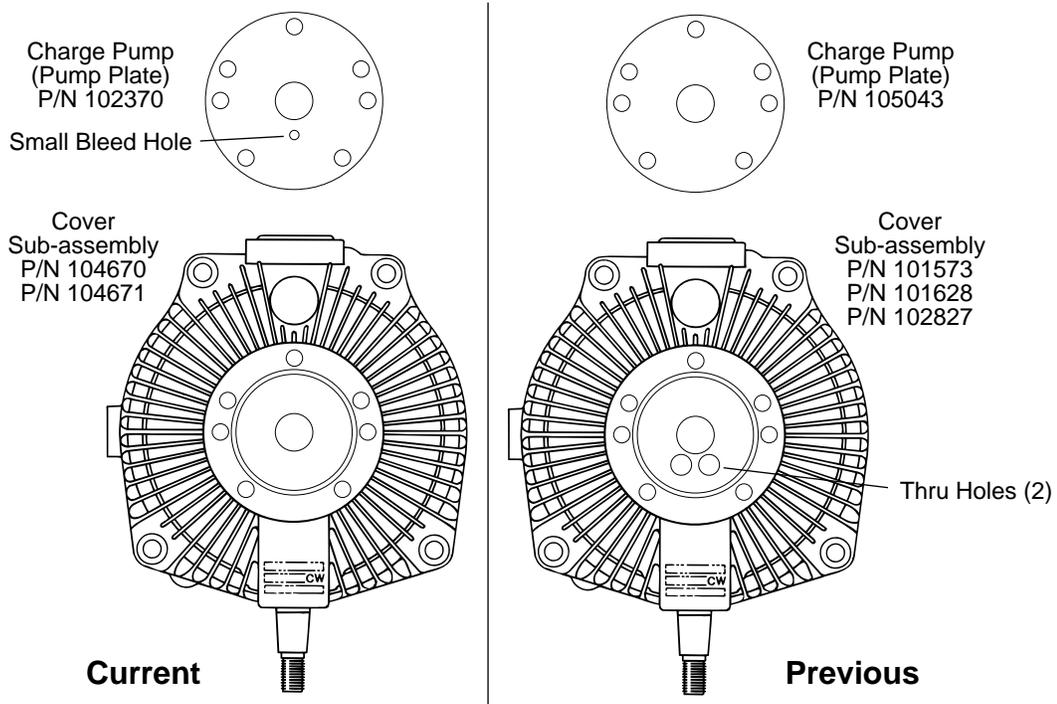
Current cover sub-assemblies are manufactured *without* thru holes between the charge pump *pump plate* and internal case, a bleed hole was added to the pump plate.

**Note:** Current Cover sub-assembly *without* thru holes, requires Pump Plate *with* bleed hole.

Cover sub-assembly *with* thru holes will require the Pump Plate *without* bleed hole.
